3RD FLOOR BOILER HOUSE SECTION VII ROOM 7.06 F

**Non-TCRA Building Assessment
Avtex Fibers Superfund Site**

Section/Building:	Section VII 3rd Floor Boiler House	Date & Time: 1/3/00 1030	
Room No./Description:	Room 7.06 F	Field Team: WW, ST, JT

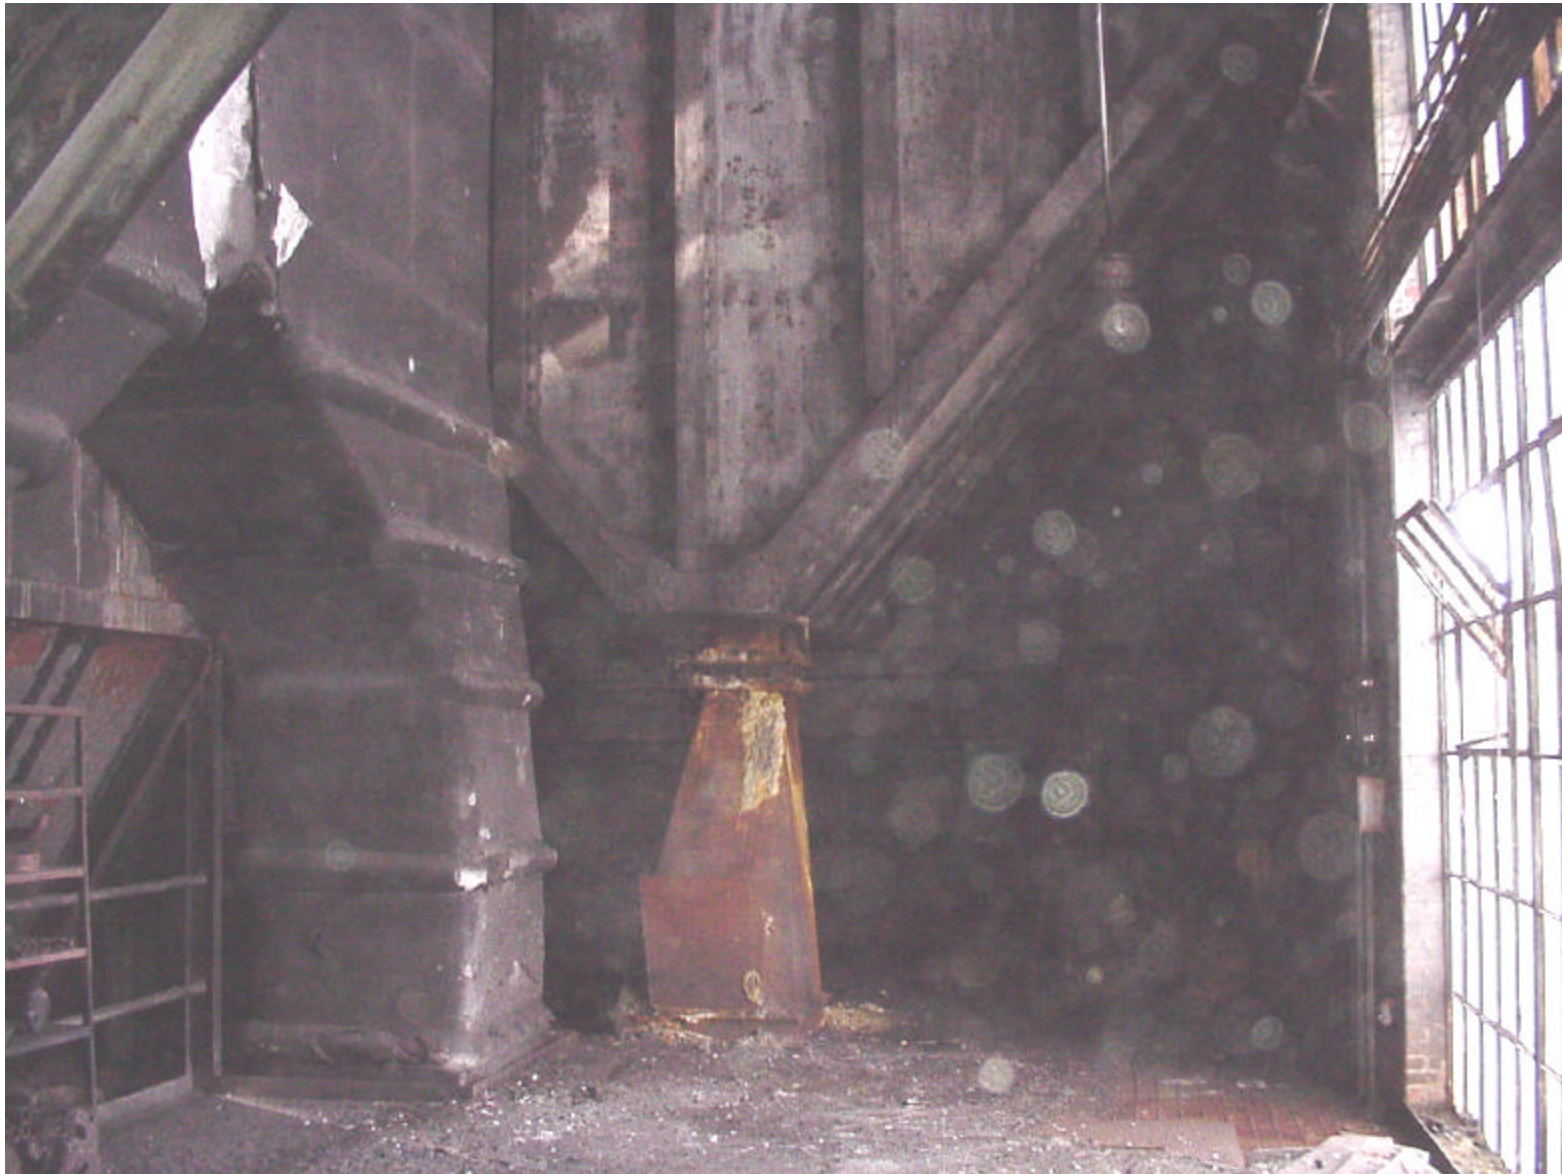
Additional Comments: The room contains approximately 100 Hg/Na vapor lights. There is a yellow solid in and around the coal hopper in the SE corner of the room.

Photograph ID	Date Taken	Section #	Room #	Room Description	Description
MVC-678		VII	7.06F	3nd Floor Boiler House	Coal hopper with yellow solid dripping from hopper

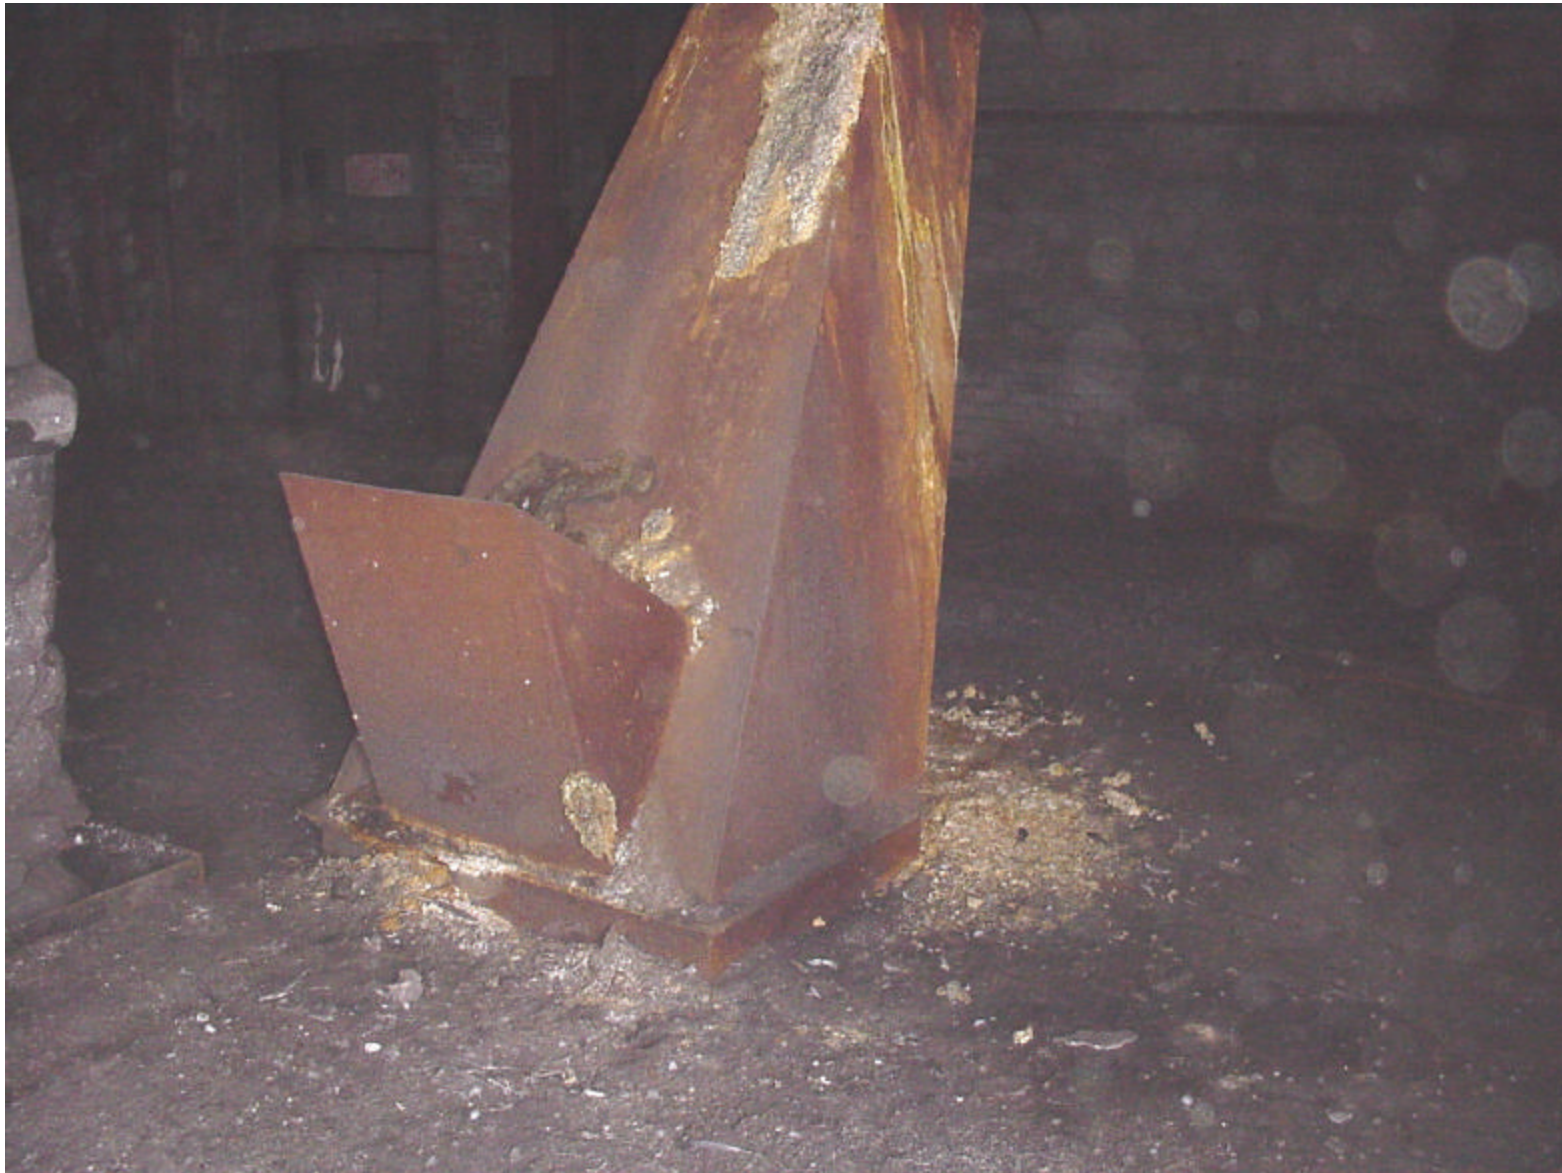
Photograph ID	Date Taken	Section #	Room #	Room Description	Description
MVC-679		VII	7.06F	3nd Floor Boiler House	Yellow solid on the floor around the hopper unit in southeast corner of room

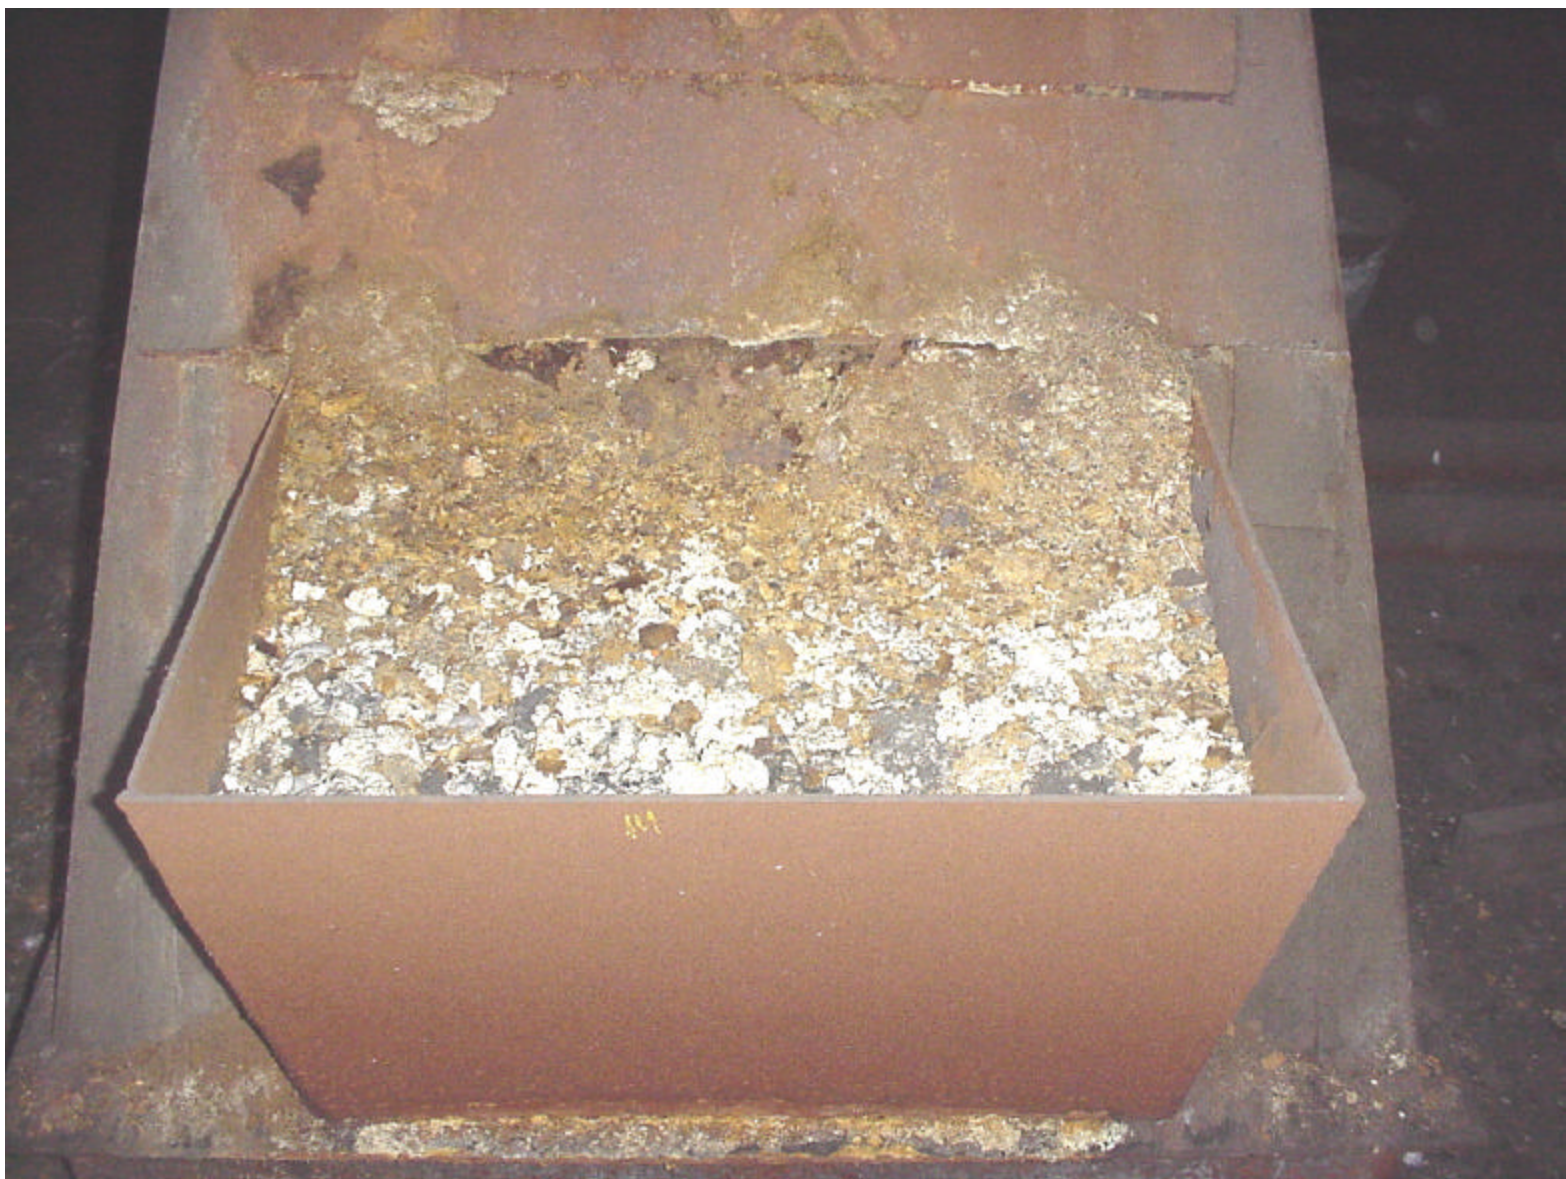
Photograph ID	Date Taken	Section #	Room #	Room Description	Description
MVC-680		VII	7.06F	3nd Floor Boiler House	Yellow solid inside hopper unit in southeast corner of room

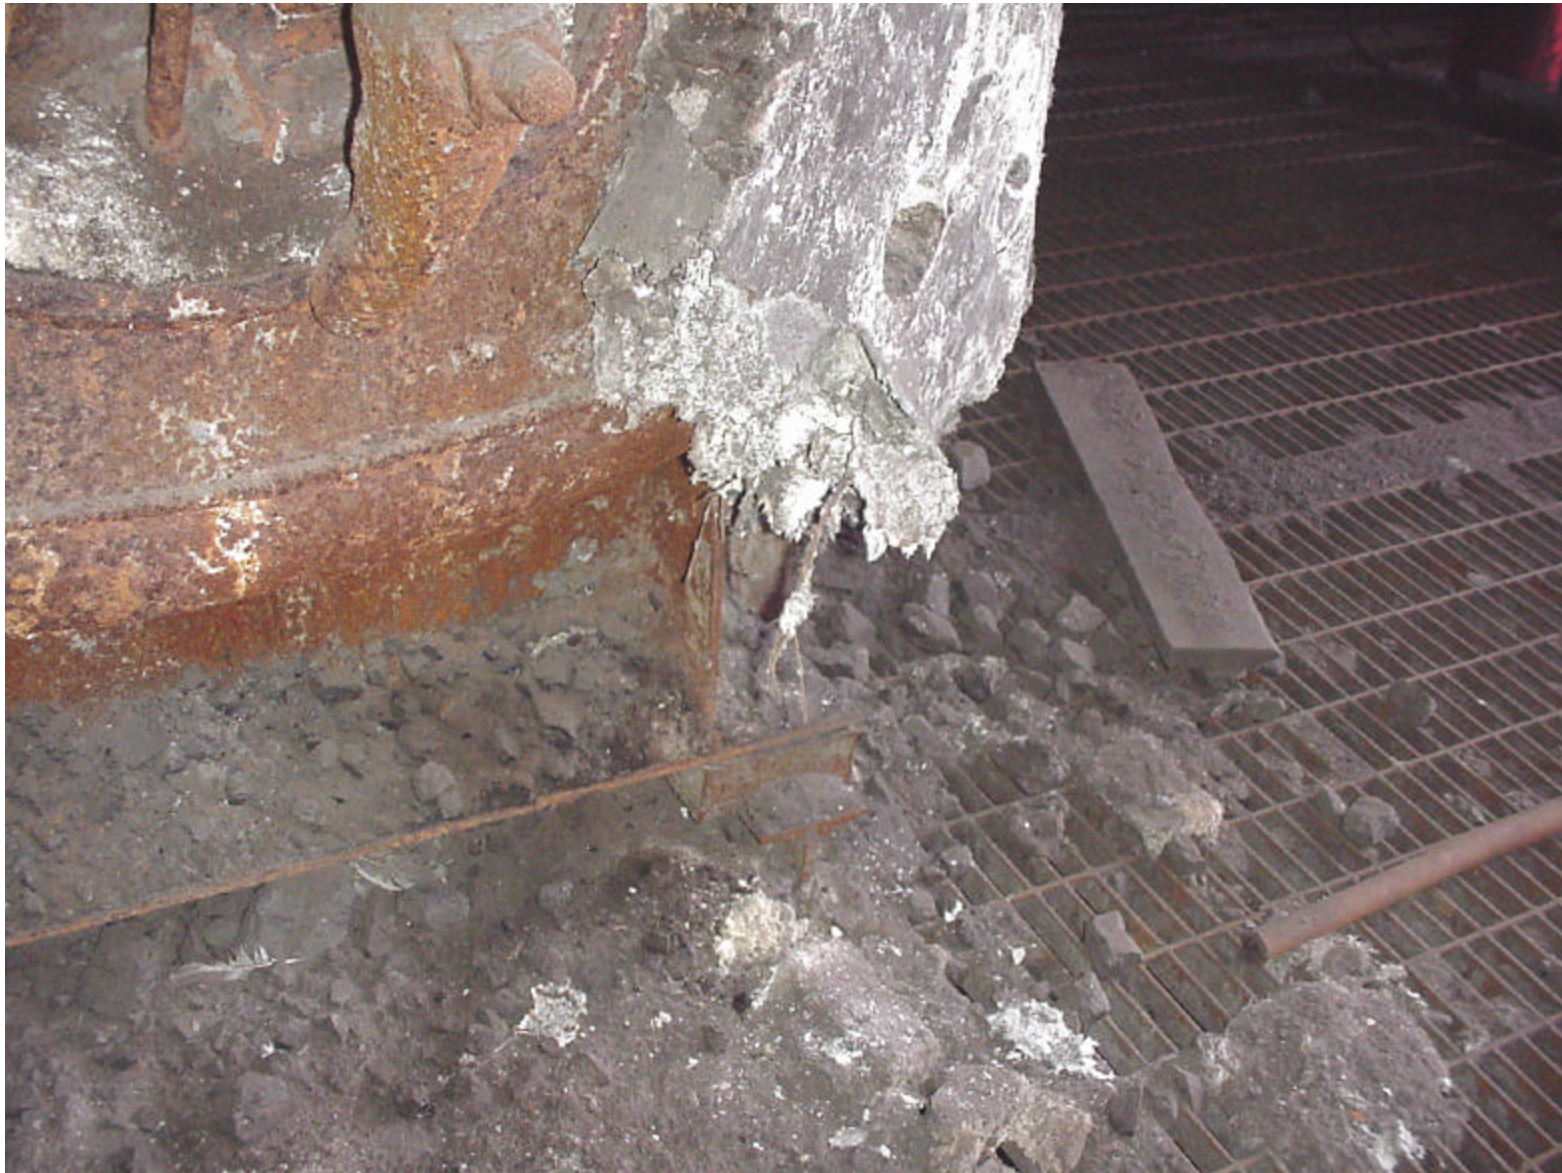
Photograph ID	Date Taken	Section #	Room #	Room Description	Description
MVC-681		VII	7.06F	3nd Floor Boiler House	PACM pipewrap is falling off onto the steel grate floor, coal + ash on floor

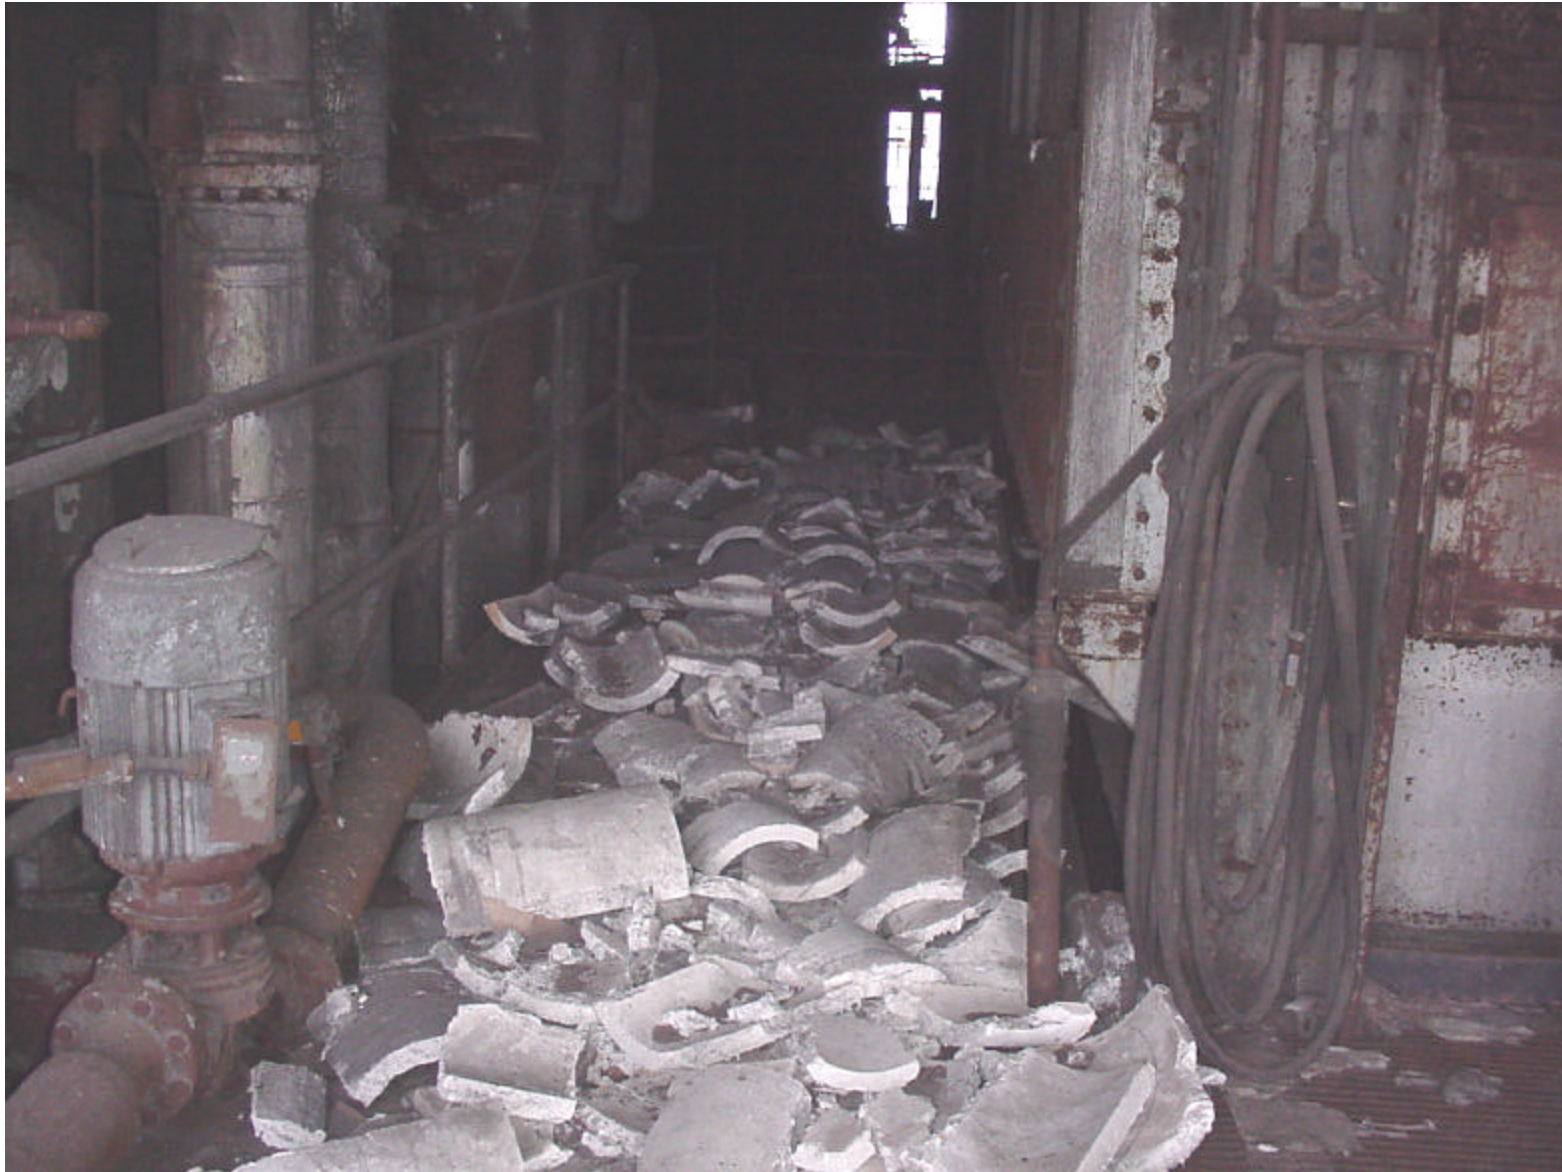
Photograph ID	Date Taken	Section #	Room #	Room Description	Description
MVC-682		VII	7.06F	3nd Floor Boiler House	PACM pipewrap on the floor in the northwest corner of the room looking east

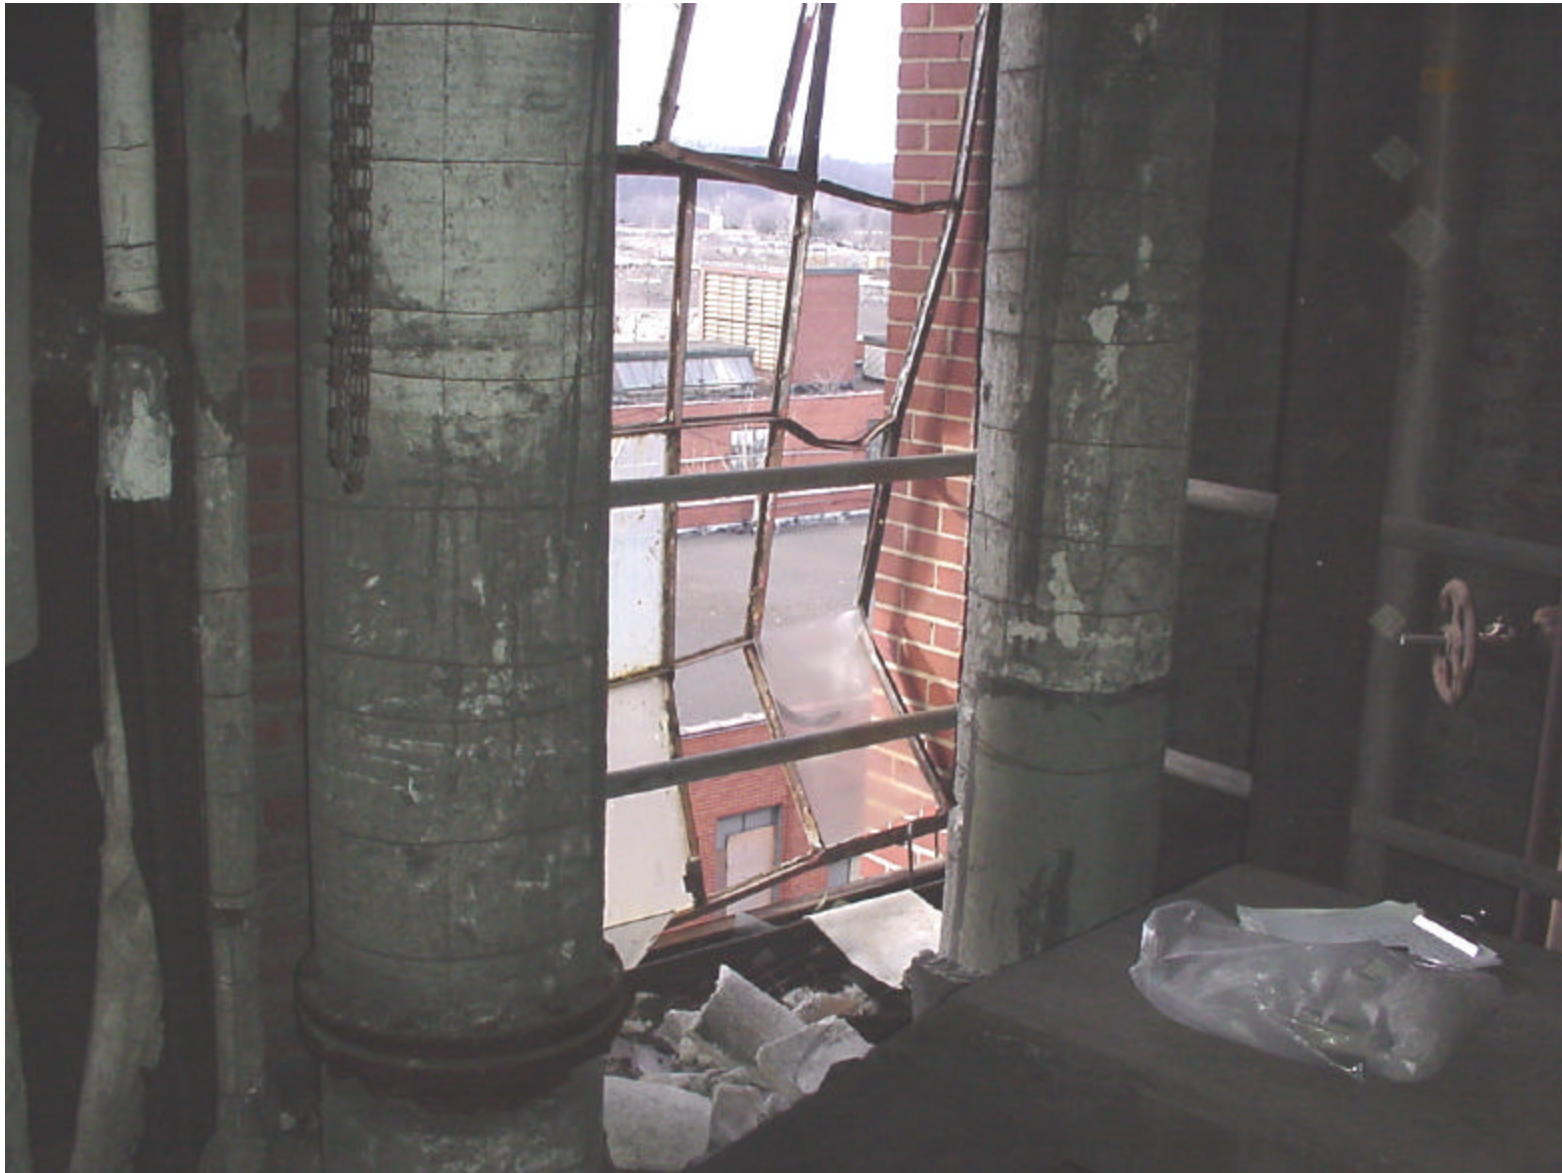
Structural Concerns: Y/N Yes, some floor grates are buckled, and window frames are falling off the building in some areas.

Photograph ID	Date Taken	Section #	Room #	Room Description	Description
MVC-684		VII	7.06F	3nd Floor Boiler House	Northwest corner of room, looking at broken window frame

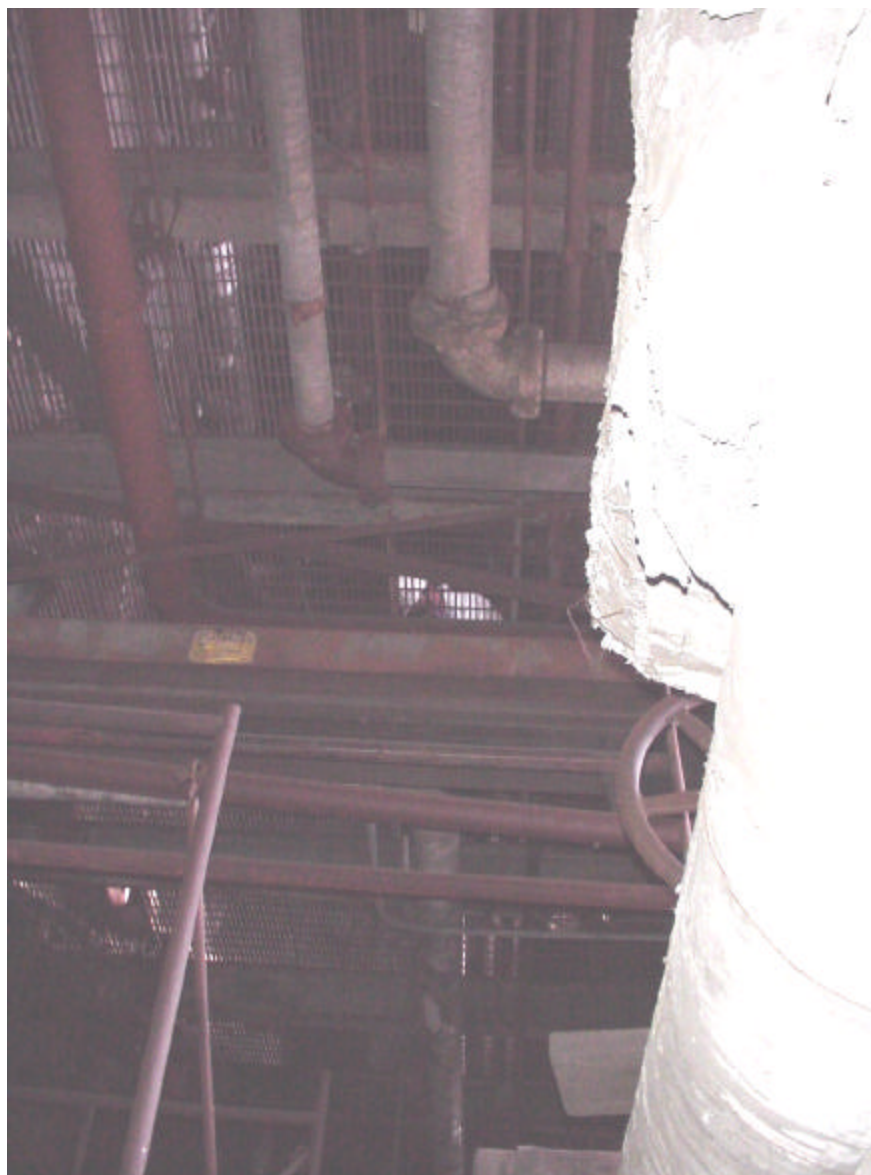
Photograph ID	Date Taken	Section #	Room #	Room Description	Description
MVC-691		VII	7.06F	3nd Floor Boiler House	Looking up at 4th floor grate from the 3rd floor

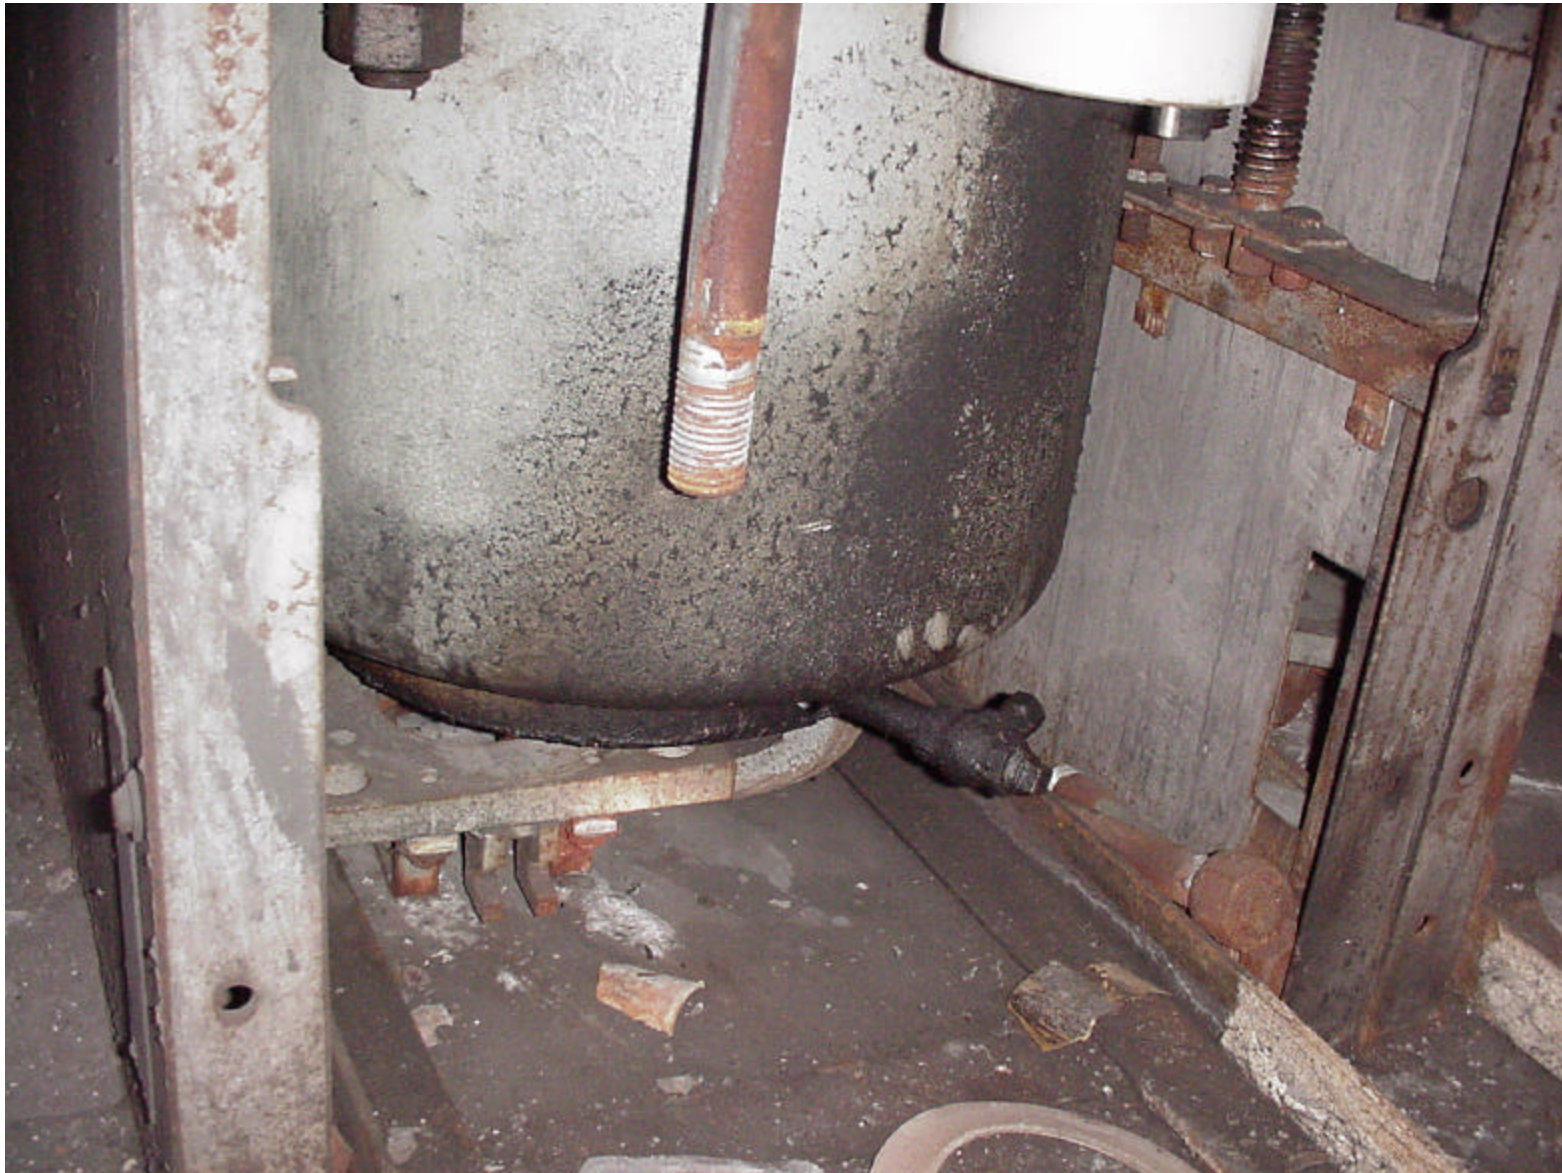
Photograph ID	Date Taken	Section #	Room #	Room Description	Description
MVC-732		VII	7.05B	2nd Floor Power House	Oil reservoir for a switch located along north wall ~15 gallon

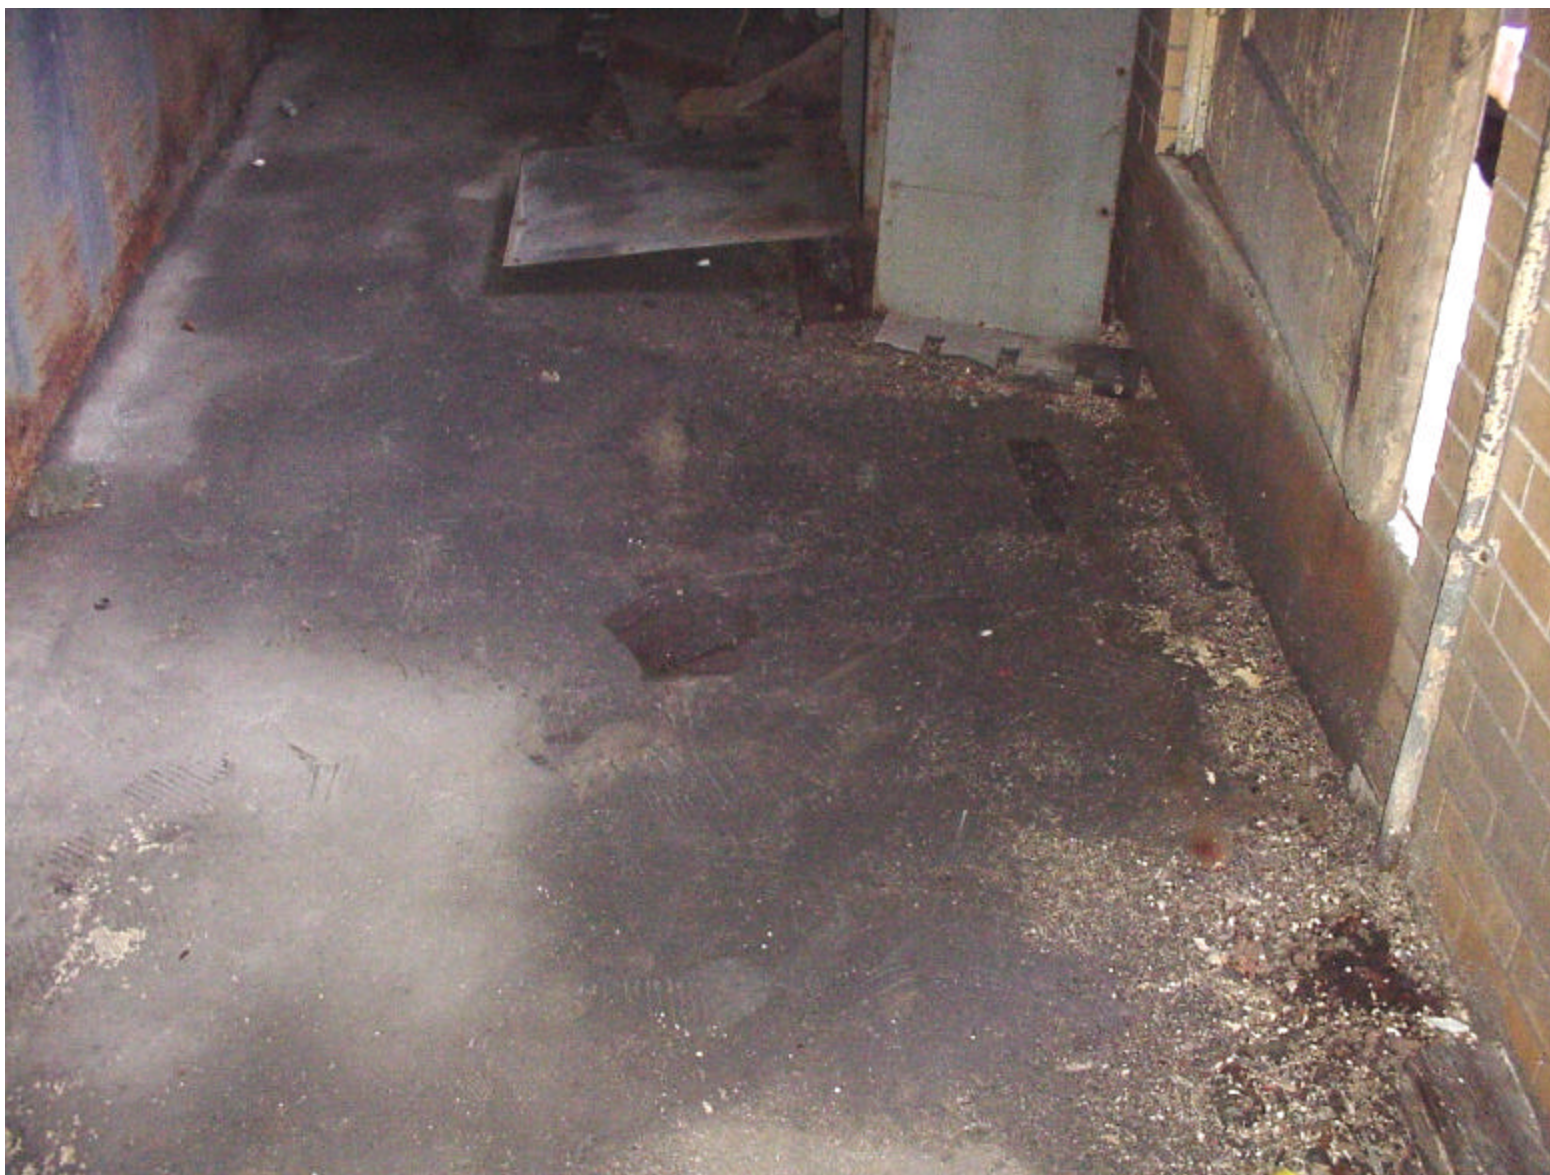
Additional Comments: There are oil stains along the N floor behind the switches and transite paneling outside.

Photograph ID	Date Taken	Section #	Room #	Room Description	Description
MVC-738		VII	7.05B	2nd Floor Power House	Oil stained floor, next to substation #4 on north end of room

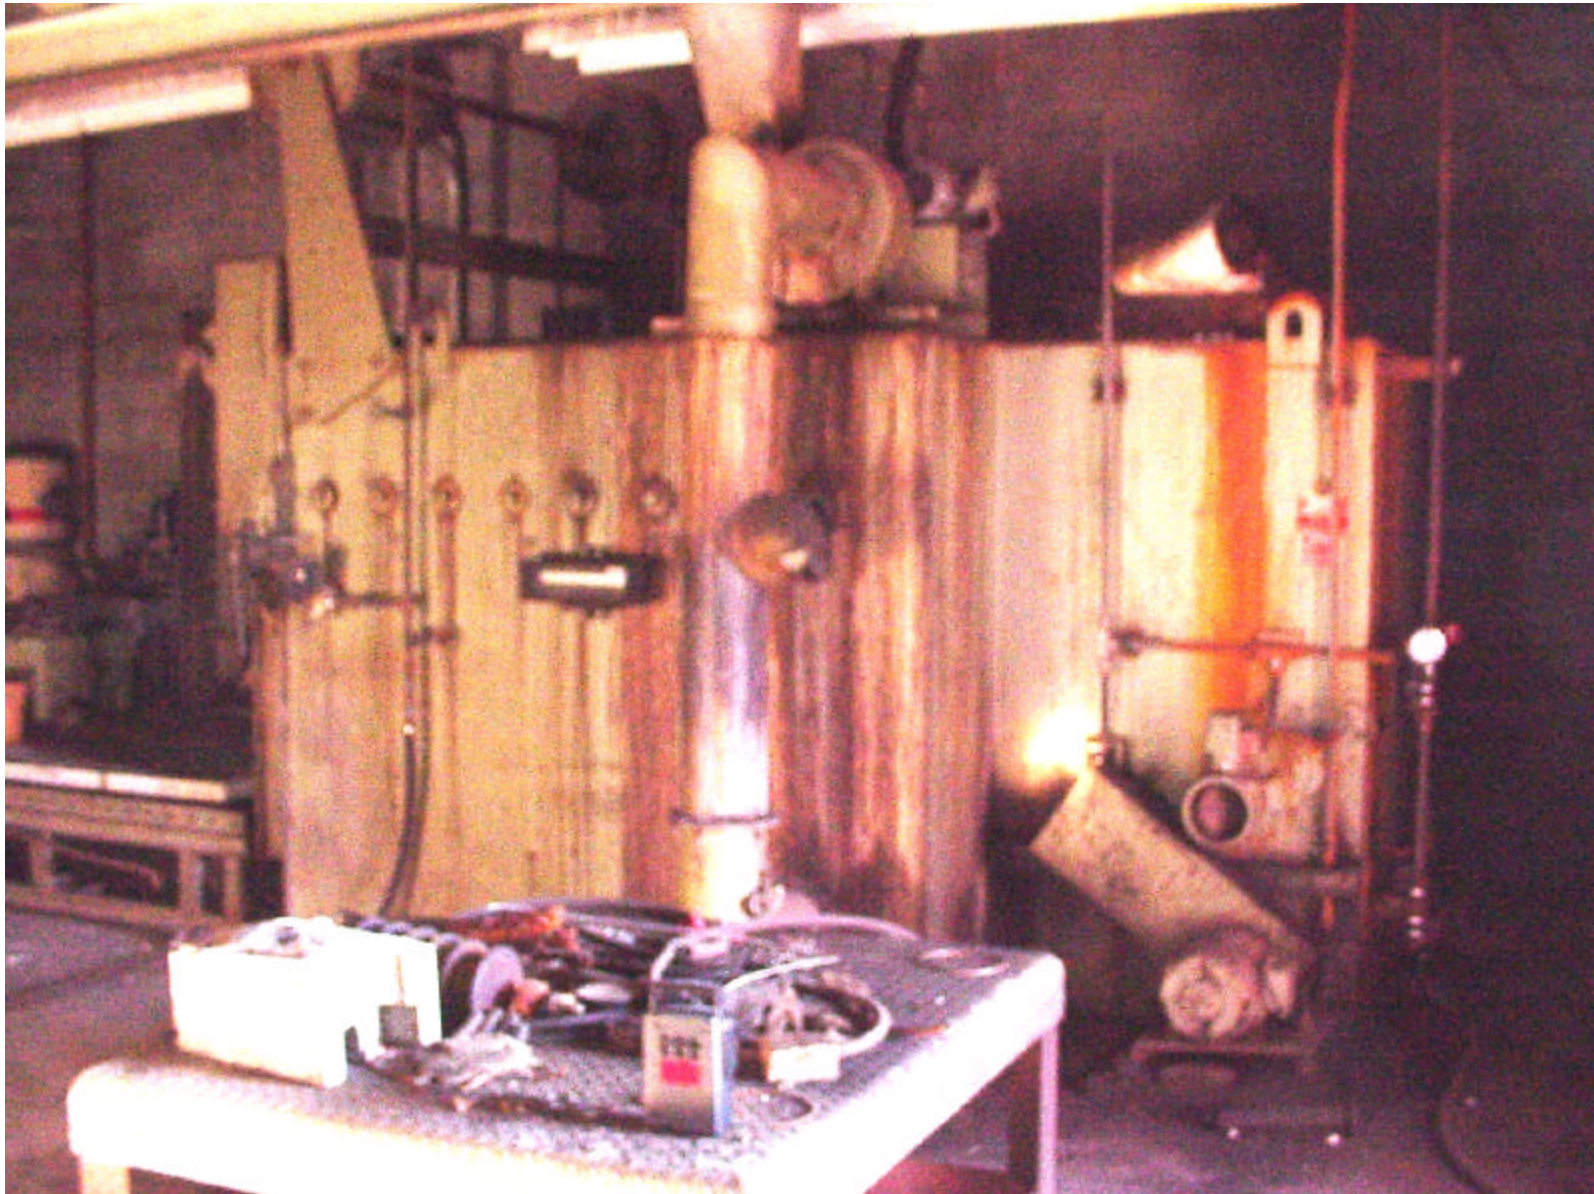
Photograph ID	Date Taken	Section #	Room #	Room Description	Description
MVC-068	11/17/99	I	1.03D	Creel Room 3rd Floor	Staining around furnace in the southwest corner of room.

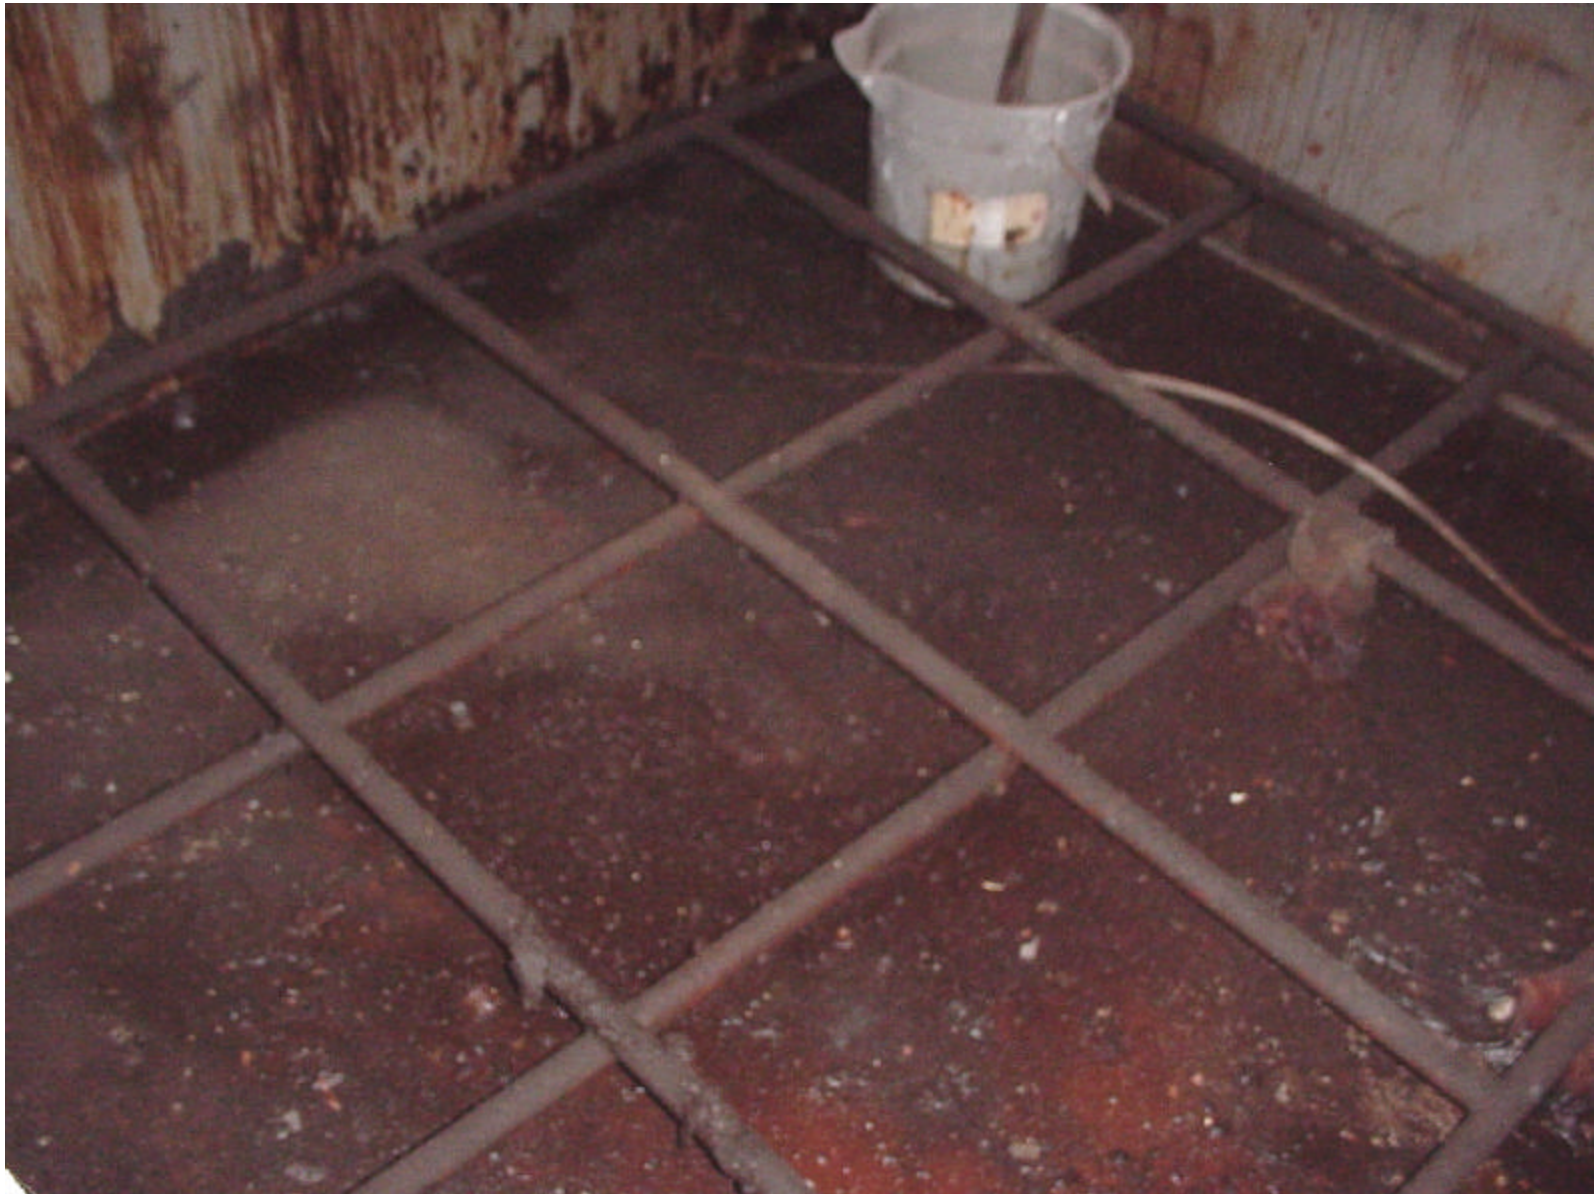
Photograph ID	Date Taken	Section #	Room #	Room Description	Description
MVC-070	11/17/99	I	1.03D	Creel Room 3rd Floor	Oily residue in easternmost vat along the north wall.

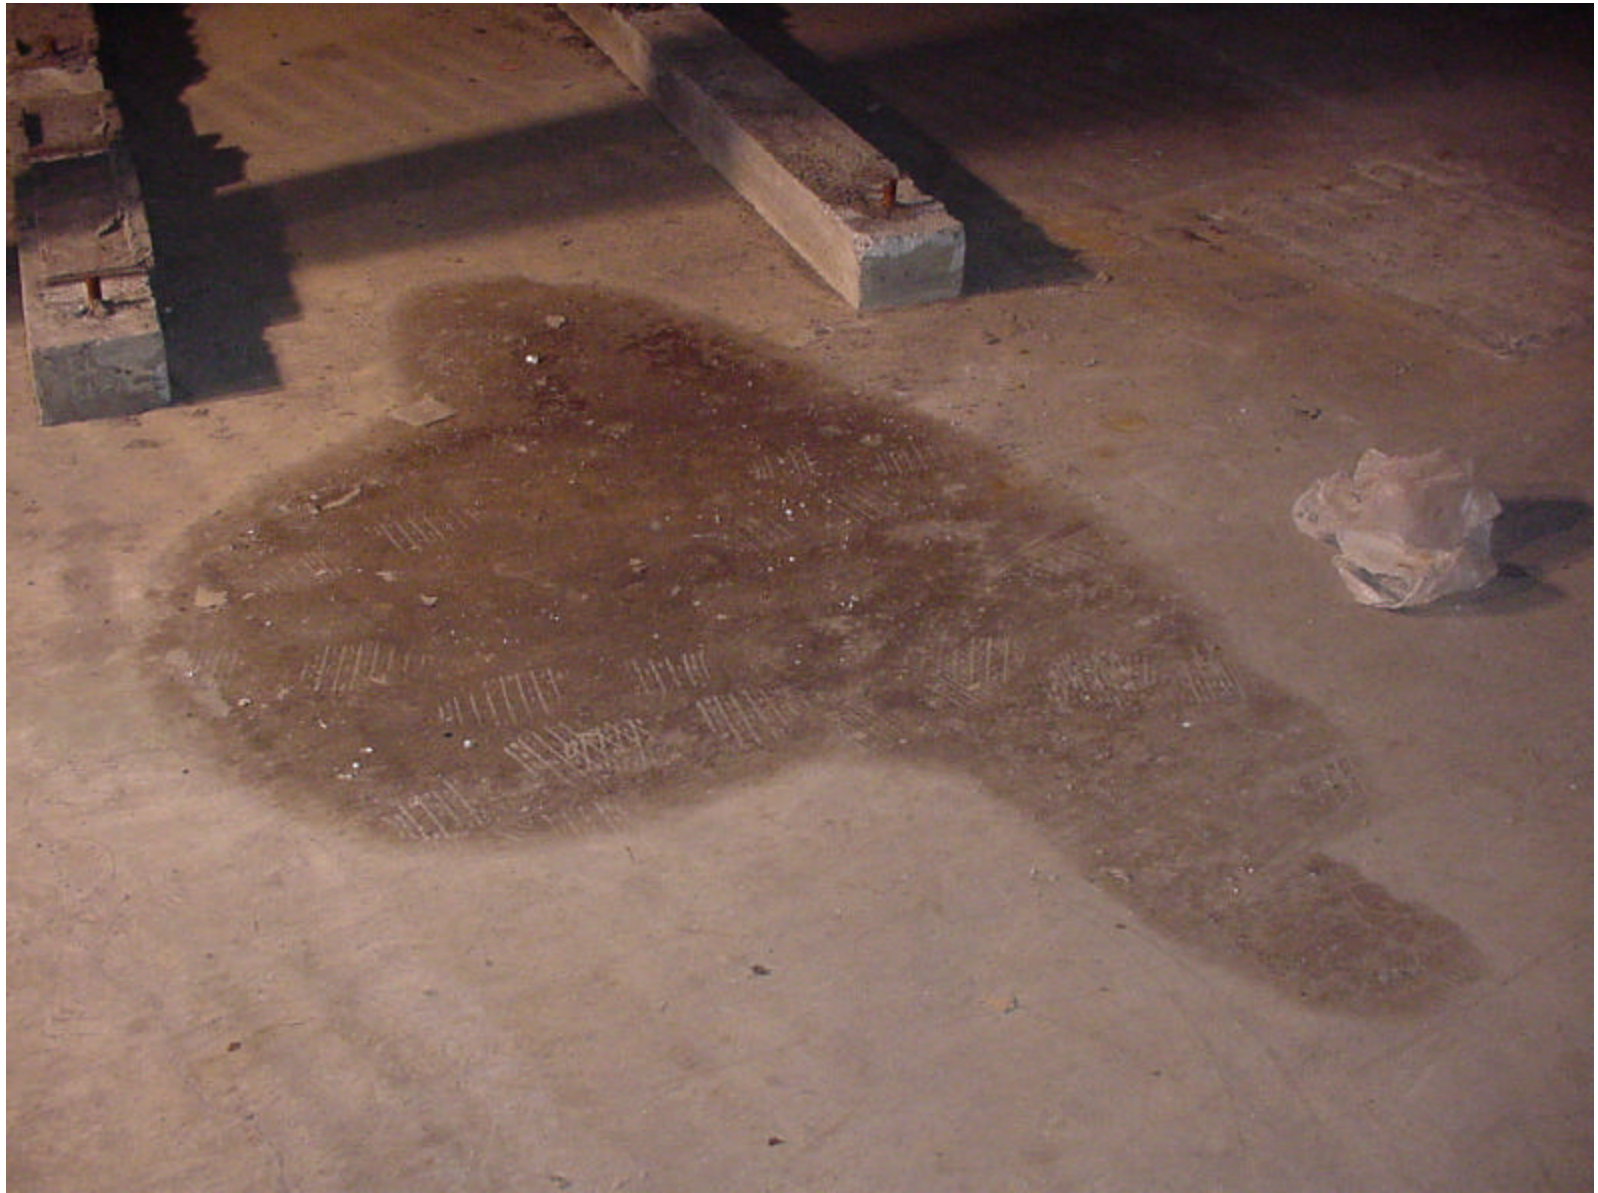
Photograph ID	Date Taken	Section #	Room #	Room Description	Description
MVC-171	11/18/99	I	1.04C	Polyester Spinning 3rd Floor	Oil staining on floor in vicinity of equipment in southeast corner of room.
